Lesson learned in Tehran DPF retrofit project

Dec 2016, Inspection Workshop, Hossein Izanloo

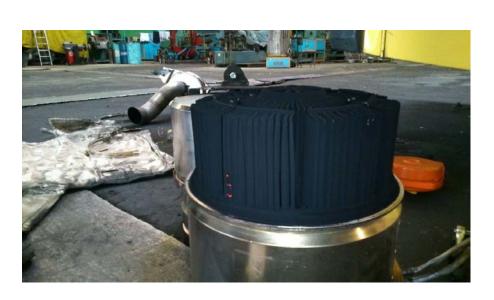
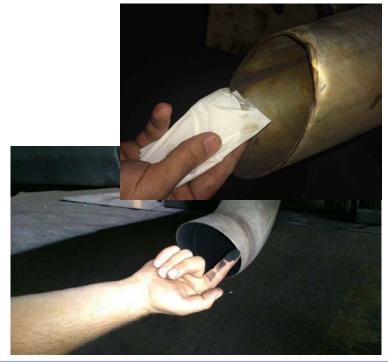
- Worn fuel injectors lead to excessive fueling
- Dirty air filter reduce air flow
- Low boost turbocharger do not produce sufficient air
- Low performance intercooler reduce air flow

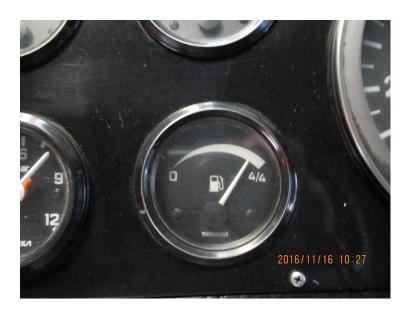
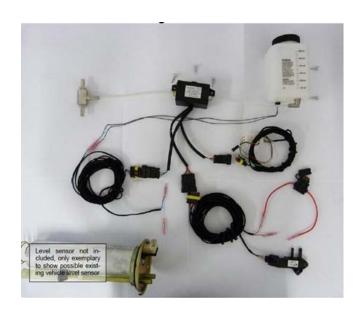
- Initial dosing adjustment is not correct
- □ Fuel tank level gage failed
- Electronic control unit failed

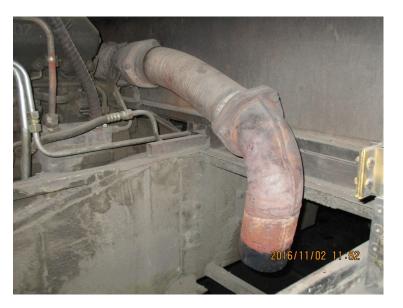
- Using high ash lube oil
- □ High rate engine wear and exhaust component corrosion
- Adding clean or used oil to fuel tank

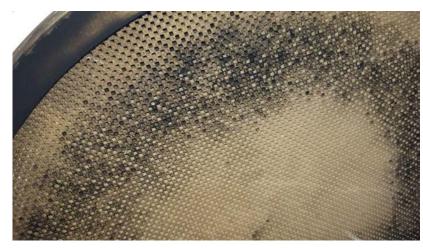
Oil leakage from Turbo made crack

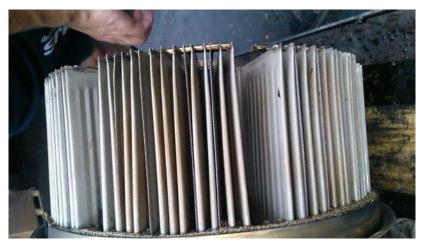
Fuel leakage from injector deformed DPF

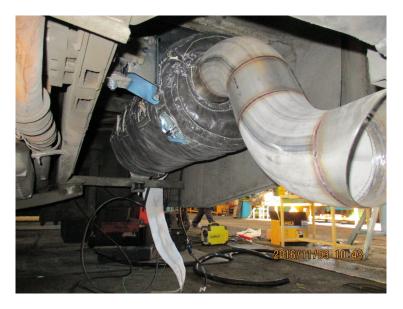
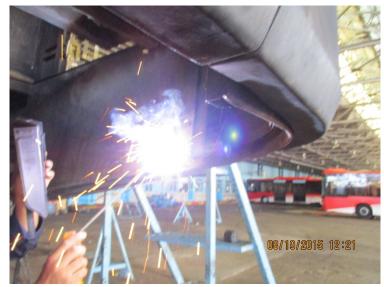
- Failure in Heat-up and cool-down of cleaning process
- Substrate dropping accident
- Hammering on mounting surface to remove ash during cleaning
- DPF vibration because of looser or missing fastener
- Leaving substrate near to welding services

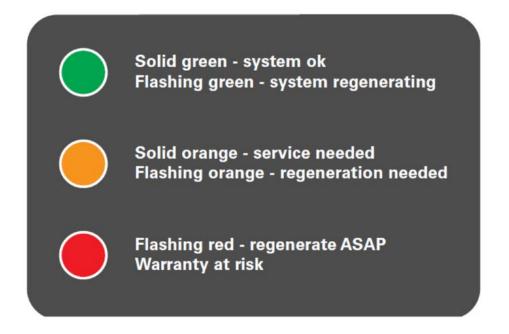
- Sensor failures
- Wiring and connectors loosening, corrosion,...
- Disconnecting, taping over or blocking displayer
- Misunderstanding the meaning of indicator lights

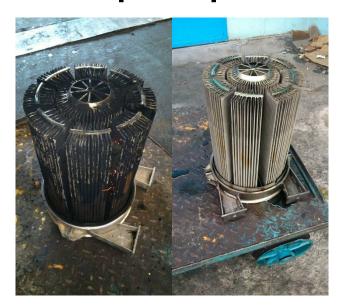
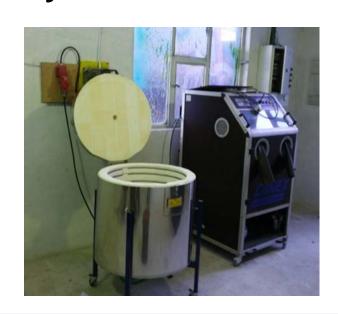
- One type of cleaning machine and cleaning procedure may not be suitable for all DPF types
- Cleaning takes time
- Visual Inspection, weighting, flow measurement and endoscope inspection are necessary
