Technical Workshop on NPTI – Tehran 14.-15.December 2016

# Technical Risks and Failures with DPF and how to avoid them

Andreas Mayer / TTM

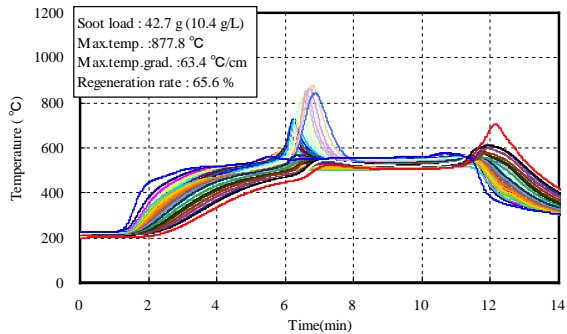
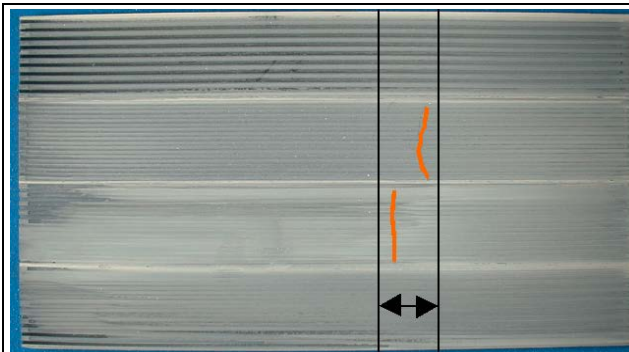
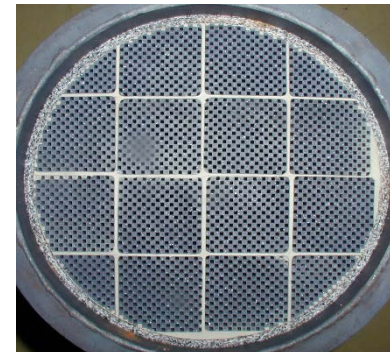
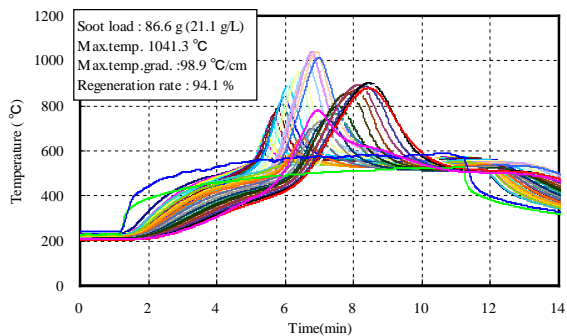
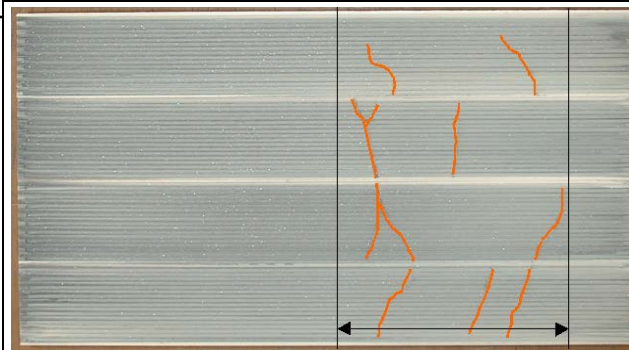
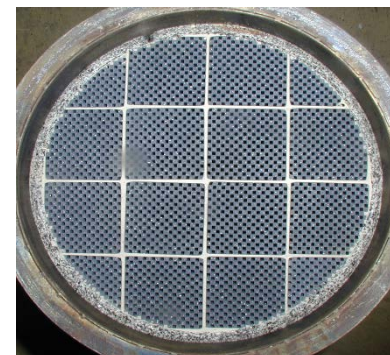
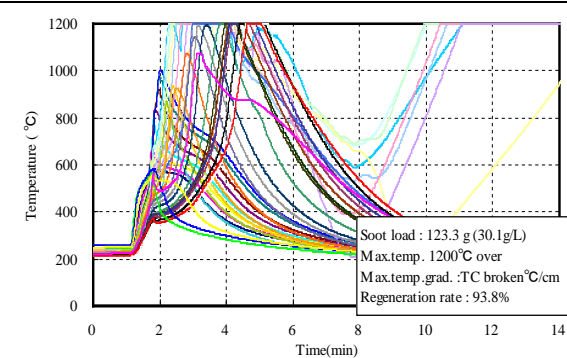
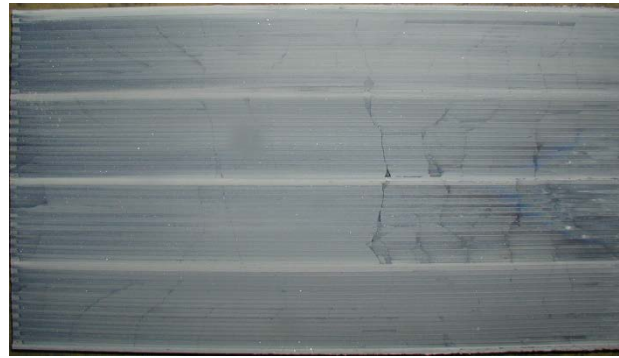
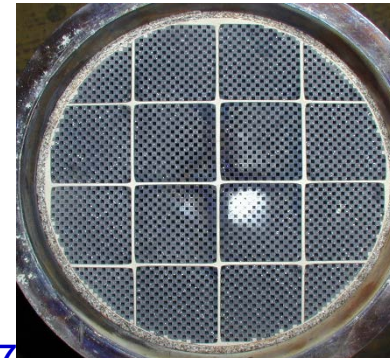
*Typical Failures*  
***Thermal Stress during  
Regeneration***

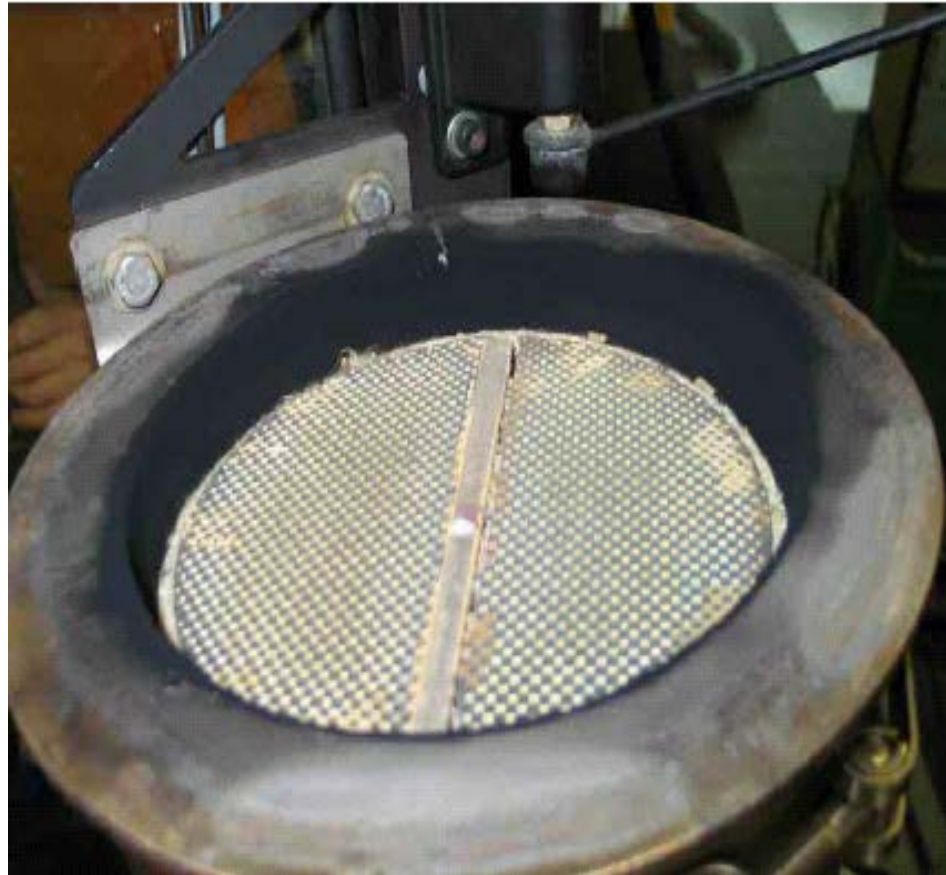
**Canning-Gap leaking due to low cycle fatigue (thermomechanic, vibrations, design mistake, manufacturing defect )**

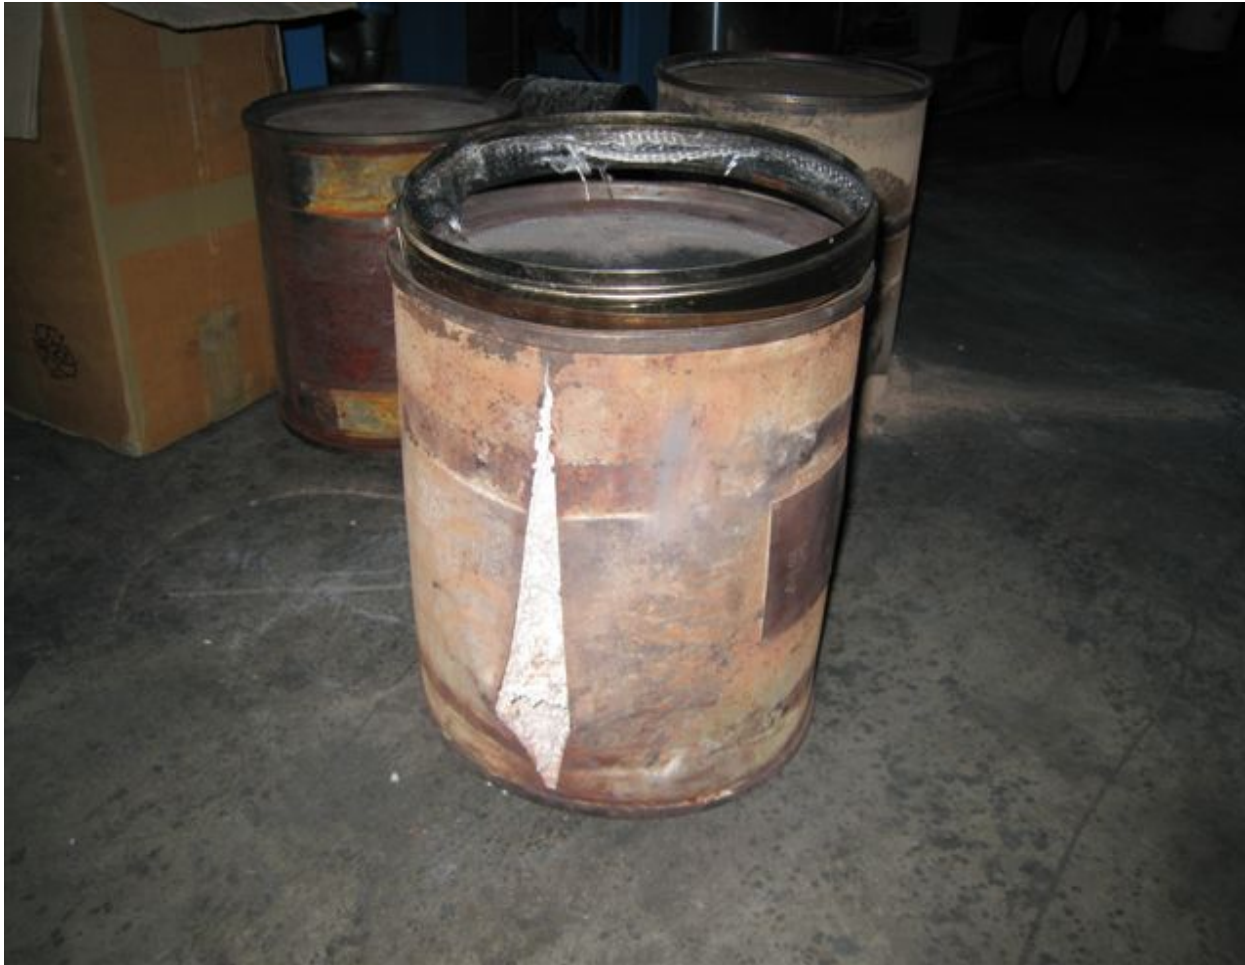
# Double-Wall-Insulation without Pressure Release

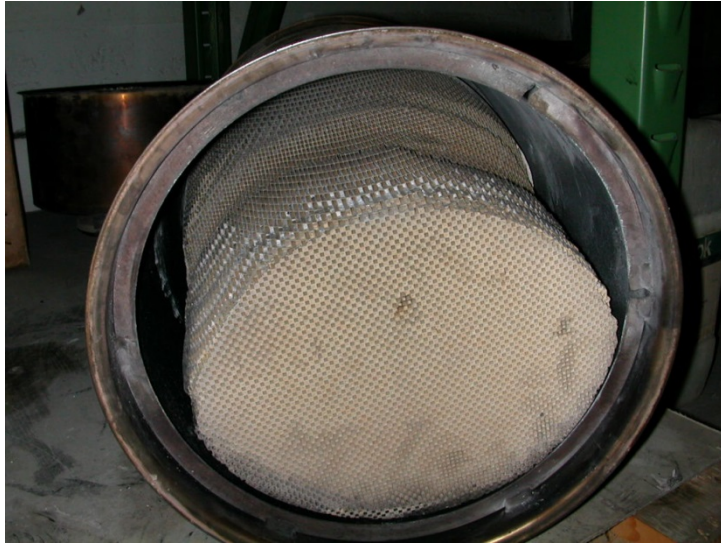
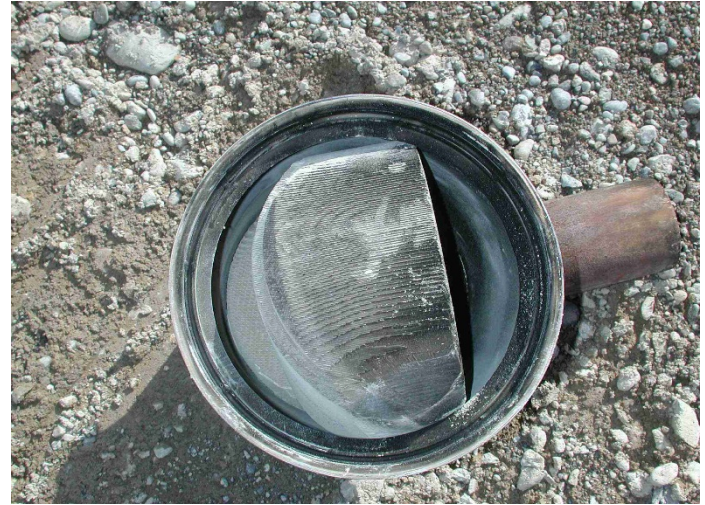
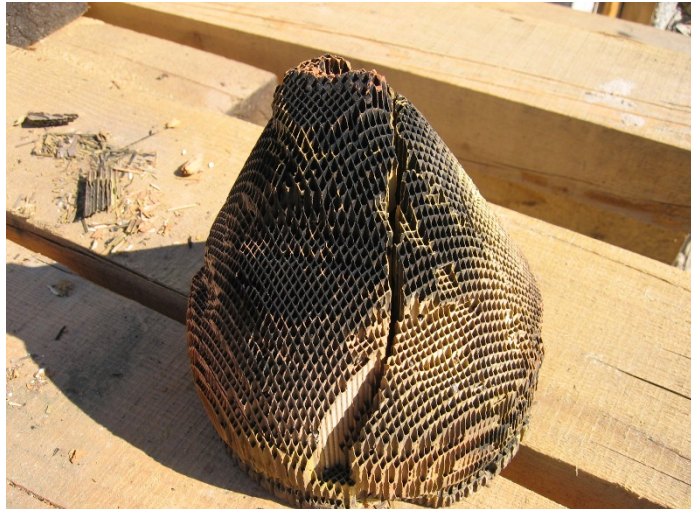
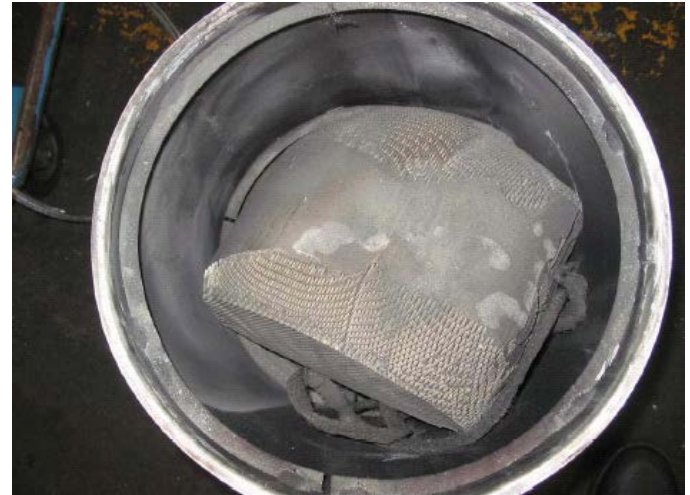
# Lose Catalysts and Filter Substrates

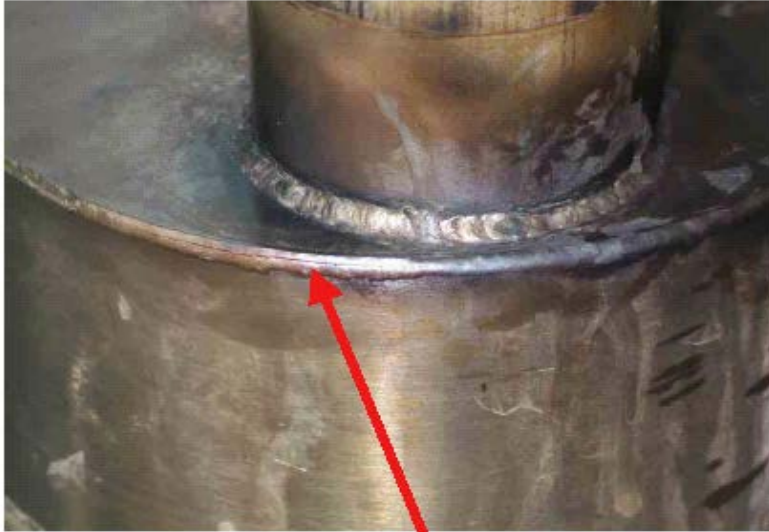
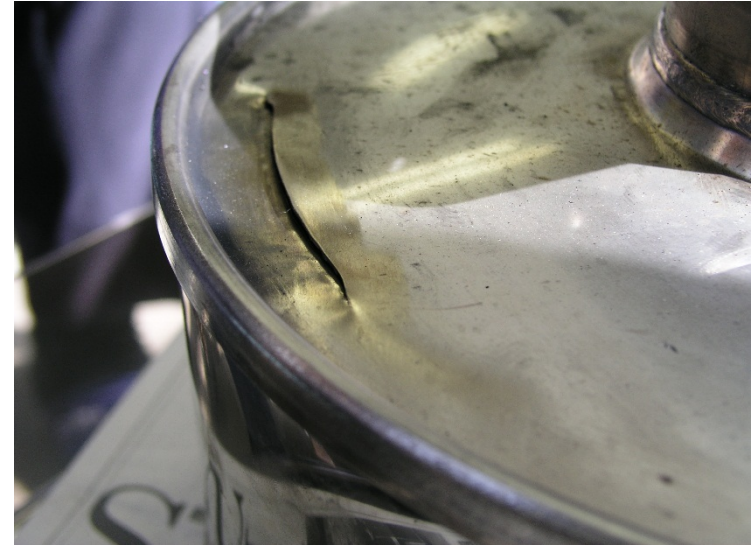
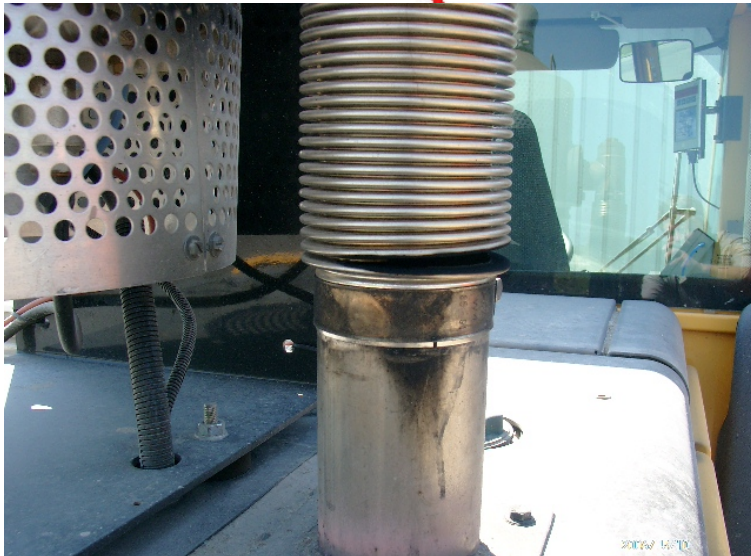
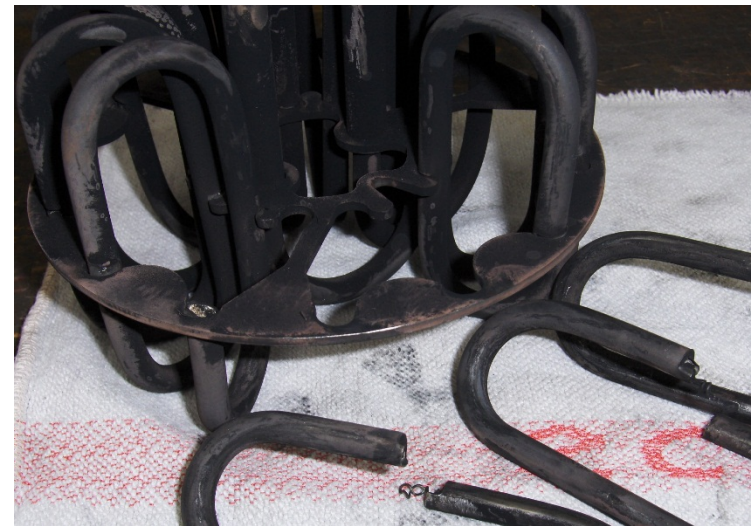
# Vibration finds every weak Point of a Design

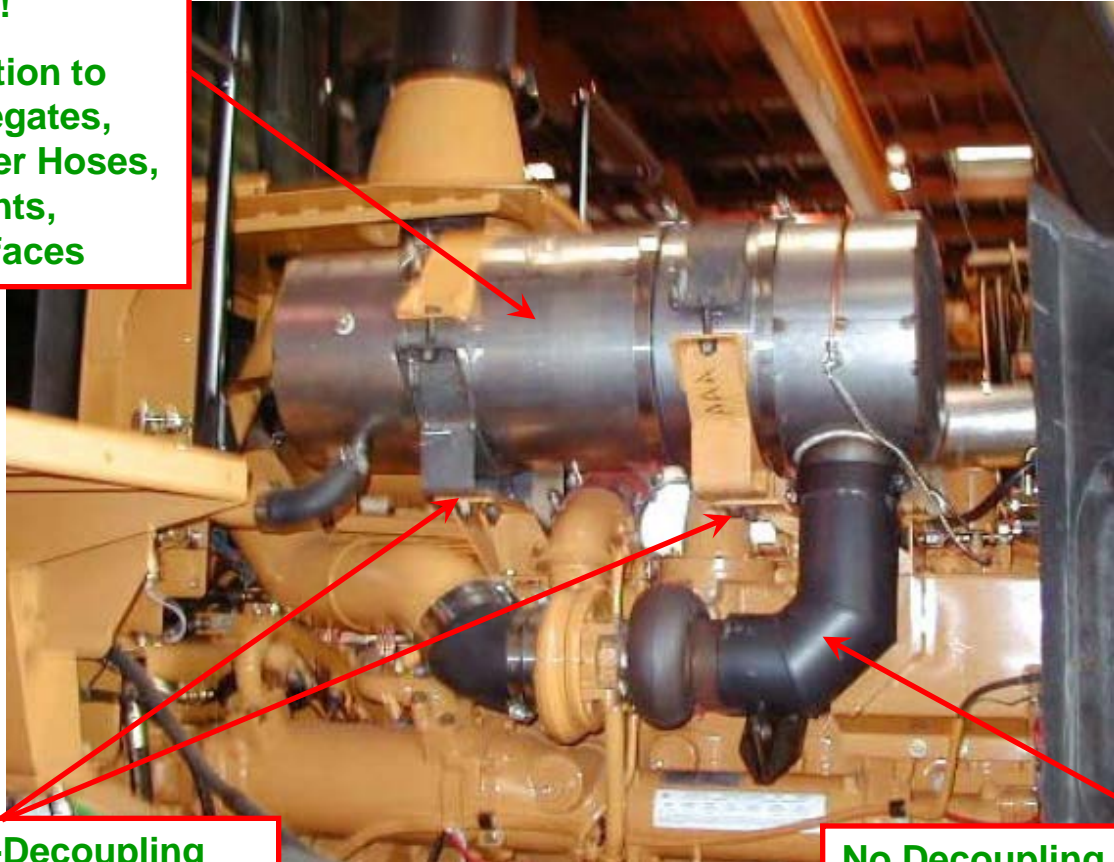
**No Insulation !**

→ Heat Radiation to  
Engine, Aggregates,  
Cables, Rubber Hoses,  
Plastic elements,  
Coloured Surfaces

**No Vibration-Decoupling  
angainst an Engine Aerea  
where 30- 50 g is a normal  
Vibration Level**

**No Decoupling against Vibration  
and Thermal Expansion**

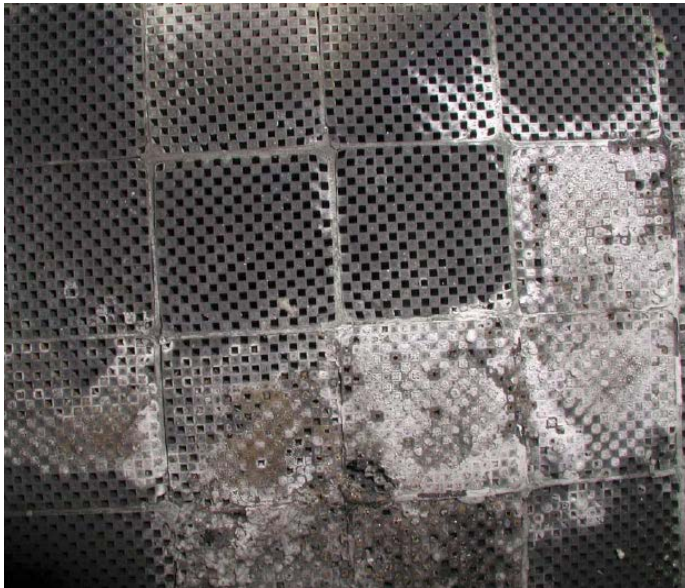
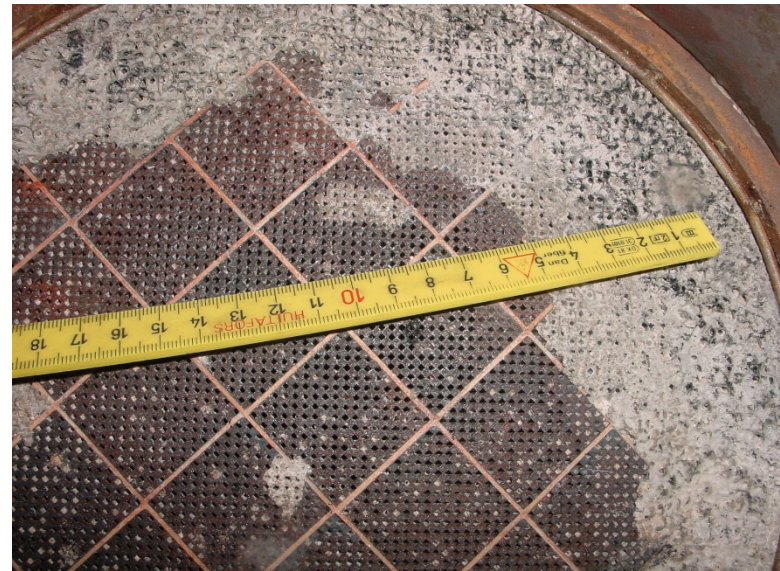
# Deposits lead to fast Plugging and rapid Increase of Back Pressure

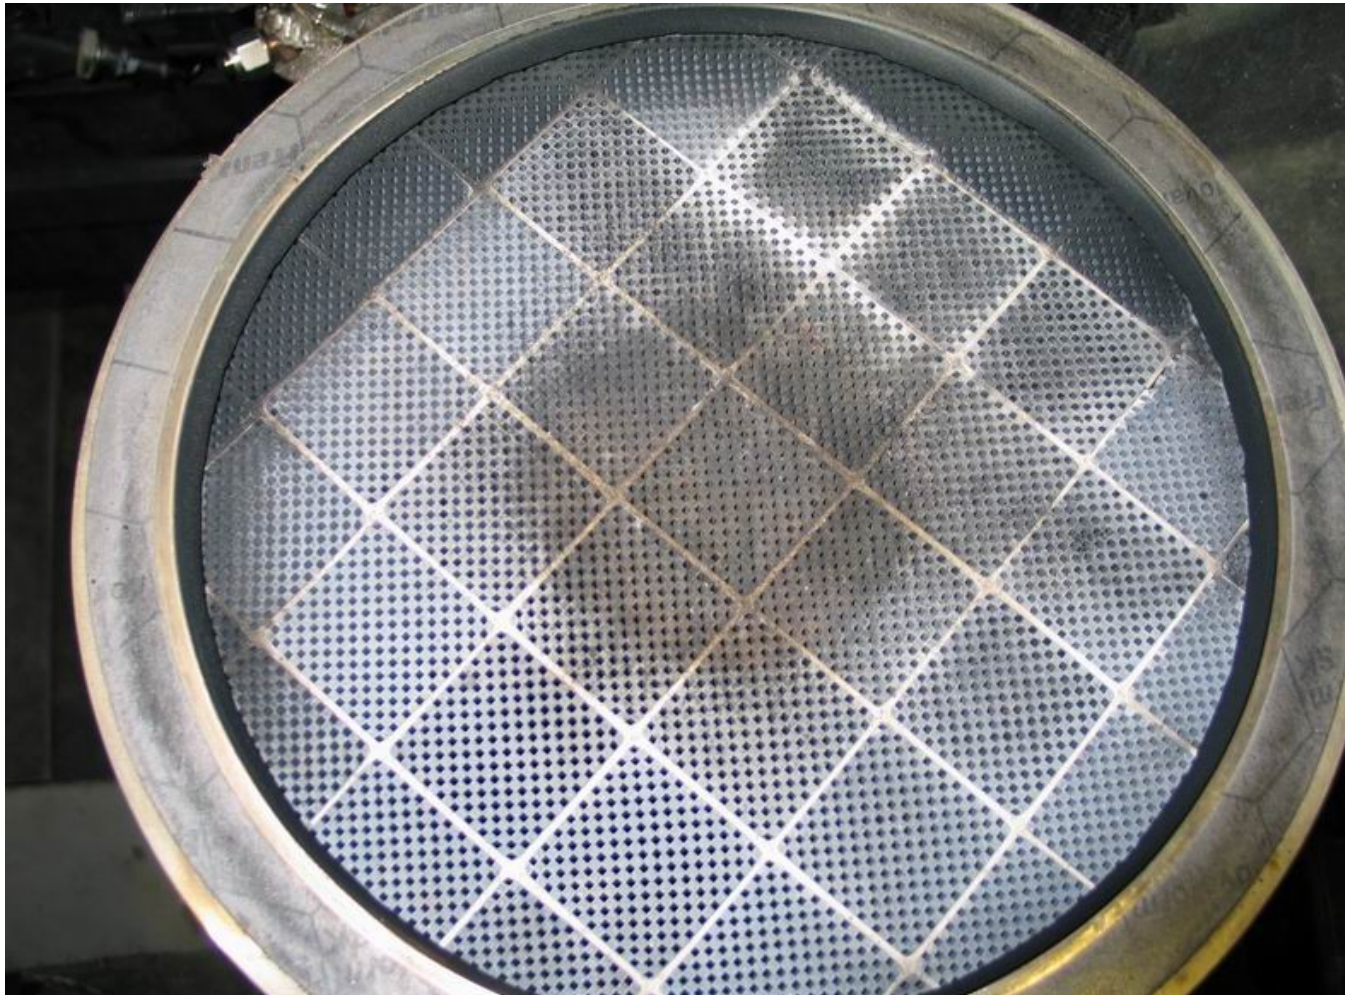
# High Lube Oil Consumption (due to Turbo Failure ?)

DOC might be covered by soot  
or poisoned or destroyed or aged  
or just not adequately coated

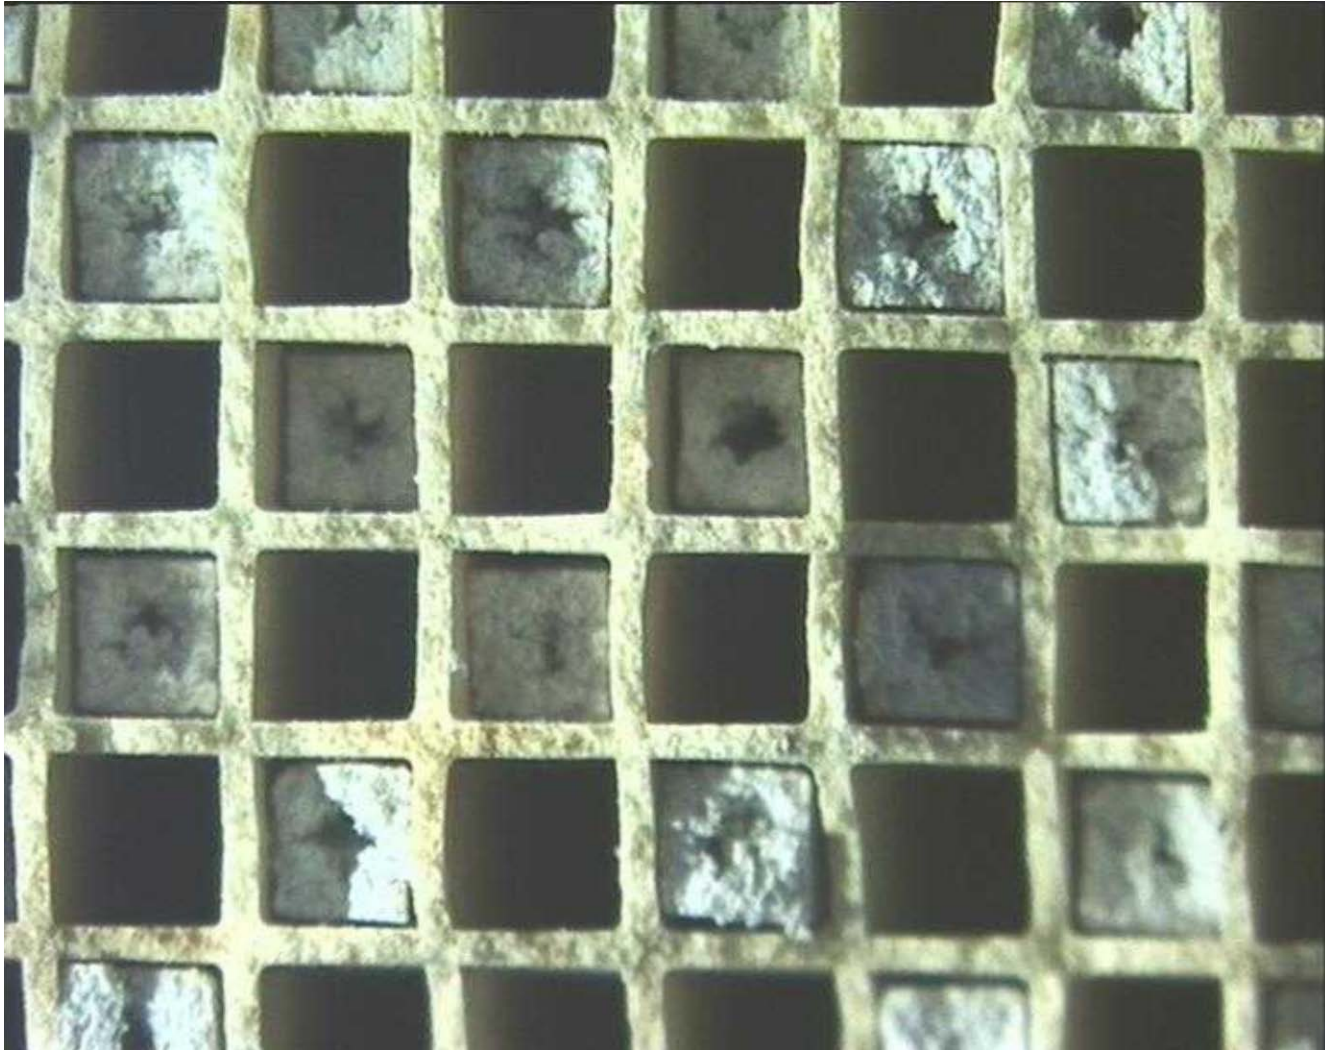
**Too late - No Cleaning possible anymore !**

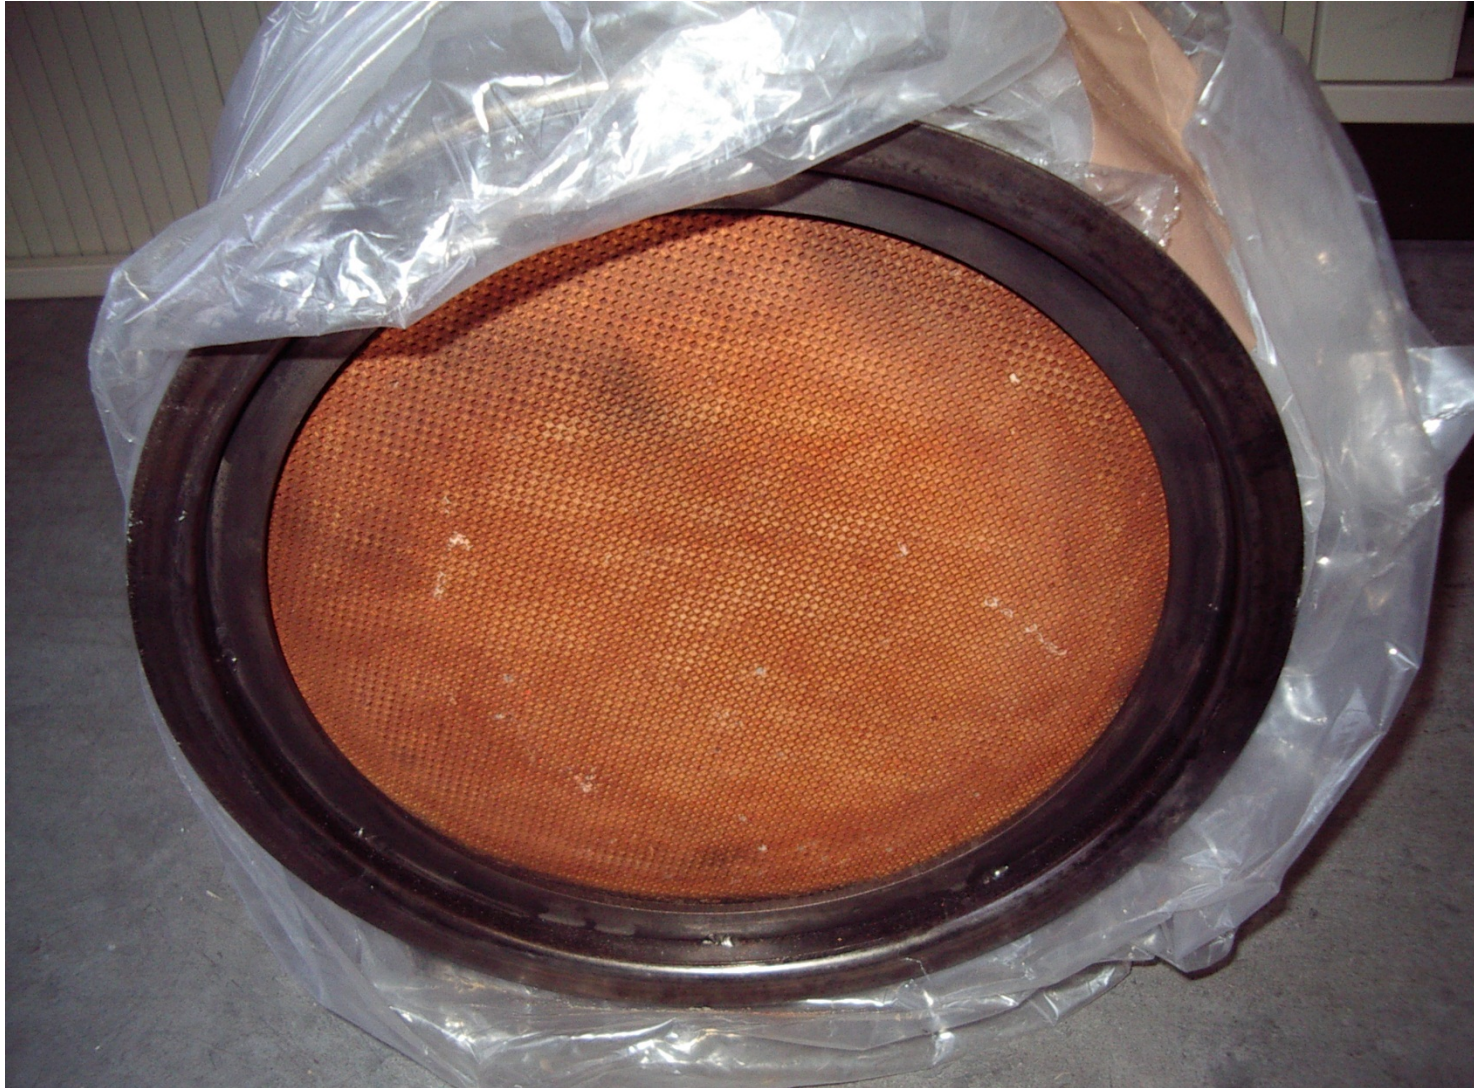
# Iron-Additive (FBC) – normal, no worry

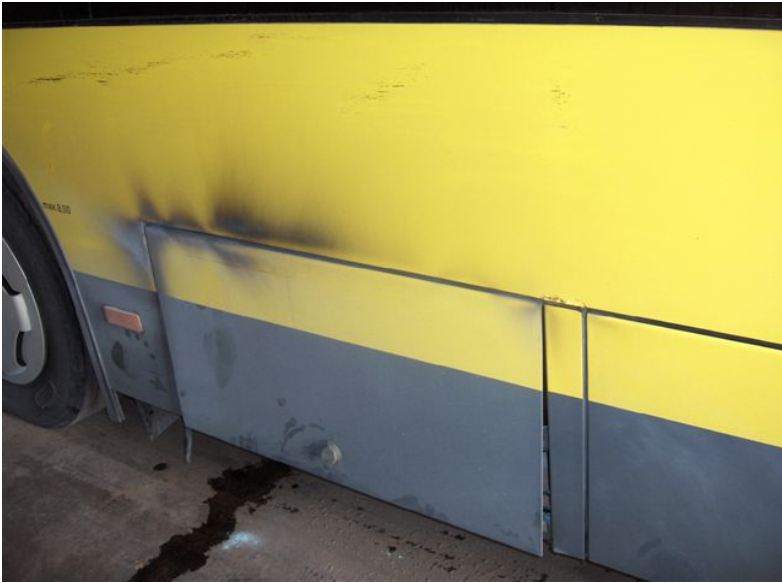
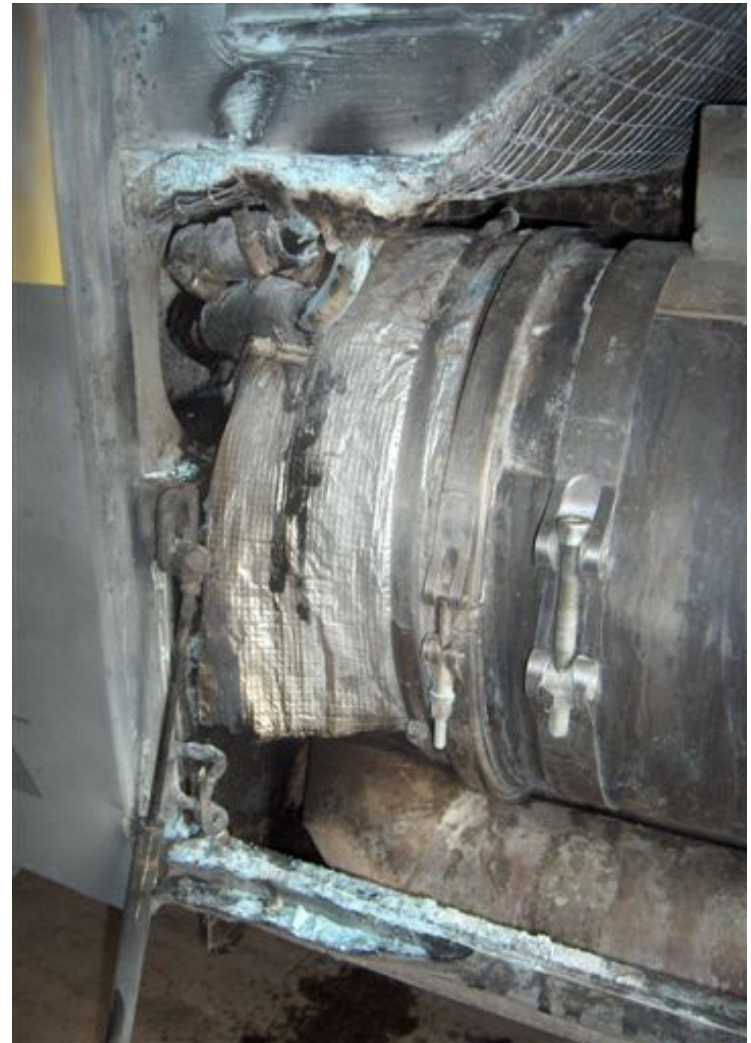
# Installation too tight (close to plastic wall)
